BOLT BERANEK AND NEWMAN INC
CONSULTING • DEVELOPMENT • RESEARCH

Report No. 1890

INTERFACE MESSAGE PROCESSORS FOR
THE ARPA COMPUTER NETWORK

QUARTERLY TECHNICAL REPORT NO. 3
1 July 1969 to 30 September 1969

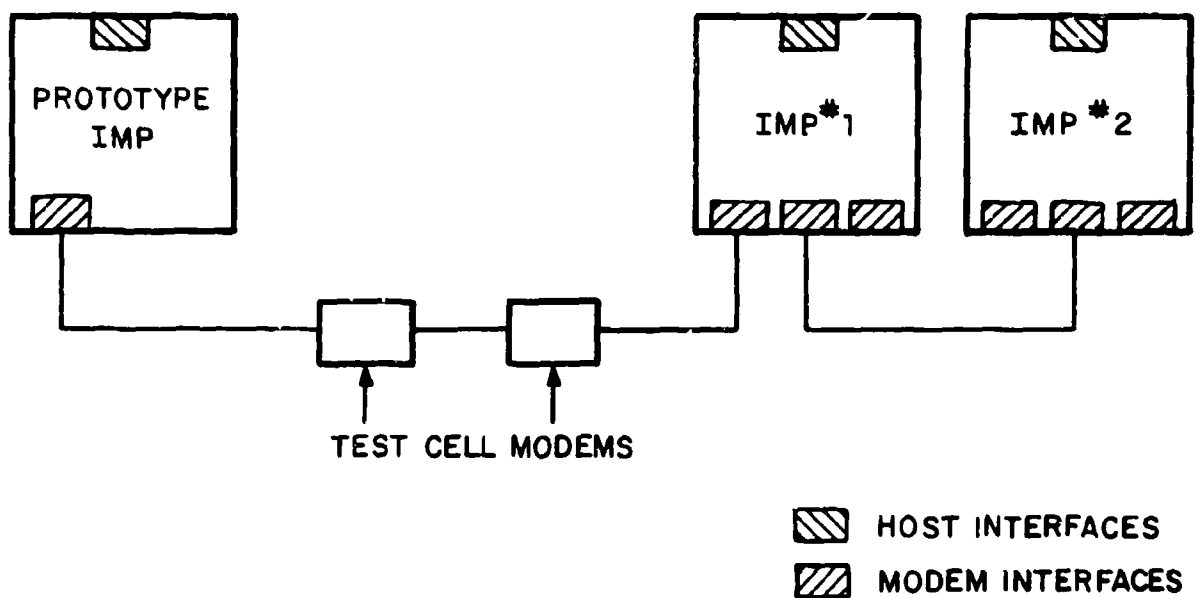
FIG. 1

A small temporary hardware patch to the Modem interfaces in IMPs 1 and 2 made possible the direct connection of these

interfaces, thereby removing the need for intervening modems. This modification allowed for the construction of a three node pseudo-network as shown in Figure 1 below:

This configuration provides a reasonably sophisticated setting for hardware testing and also allows for debugging of configuration dependent features (e.g., routing) of the operational program. An equivalent configuration was constructed using IMP No. 3 to replace IMP No. 1 after the latter had been shipped to UCLA.

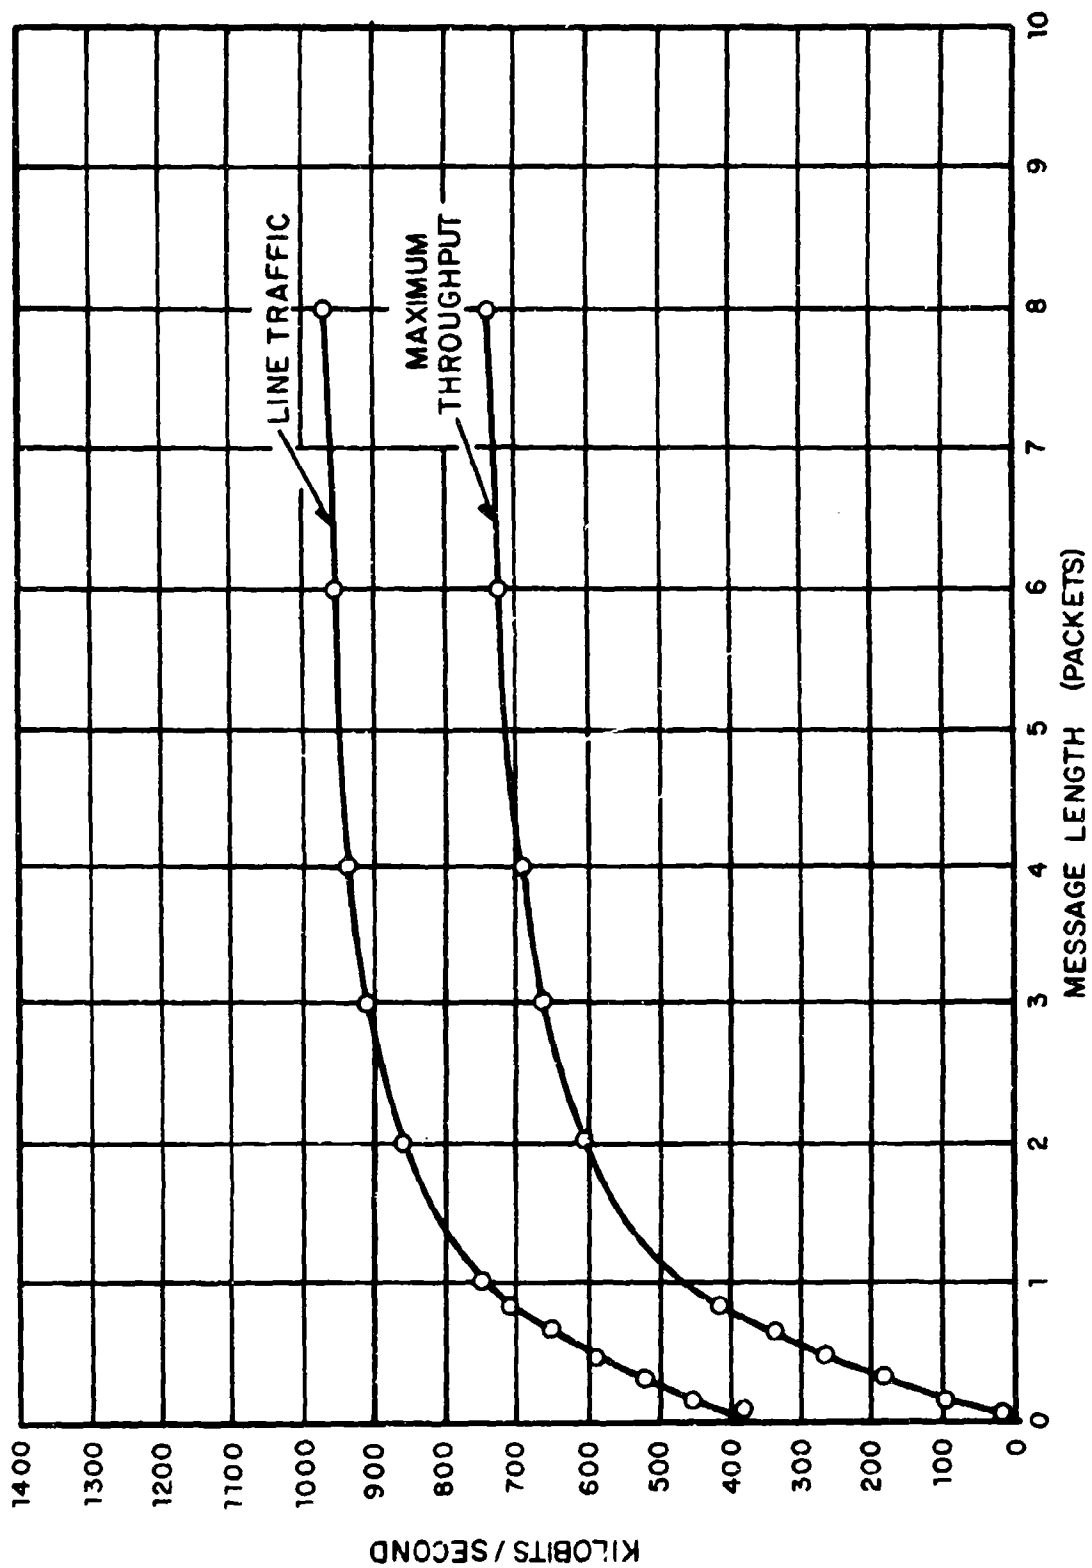
FIG. 2

The maximum IMP throughput of approximately 700,000 bits/second is achieved with large (8 packet) messages on nineteen effective channels. A curve of maximum throughput as a function of message length is shown in Figure 2. The difference between the throughput curve and the line traffic curve represents overhead.

We adopt the IMP throughput in bits/second as a measure of IMP performance. The throughput is the maximum number of

Host data bits that may traverse an IMP each second. The actual number of bits entering the IMP each second is somewhat larger than the throughput because of such message overhead as headers, RFNMs and acknowledgements. Each packet on the phone lines contains seventeen characters of overhead, thirteen of which are removed before the packet enters an IMP.
